DELAWARE RIVER BASIN  
RACCOON CREEK, GLOUCESTER COUNTY  
NEW JERSEY

# WRIGHTS MILL DAM

## NJ 00432

PHASE 1 INSPECTION REPORT  
NATIONAL DAM SAFETY PROGRAM

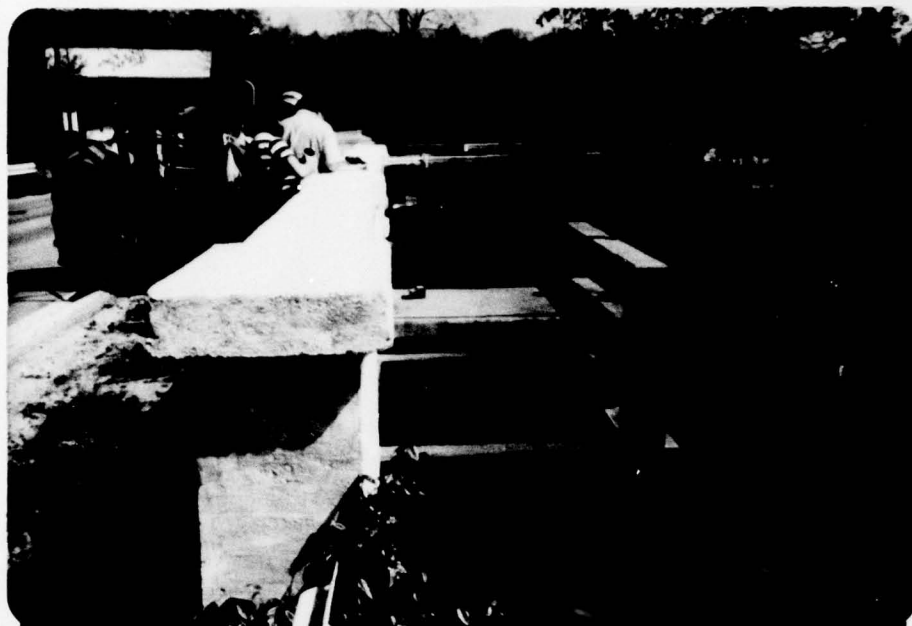
View of Spillway

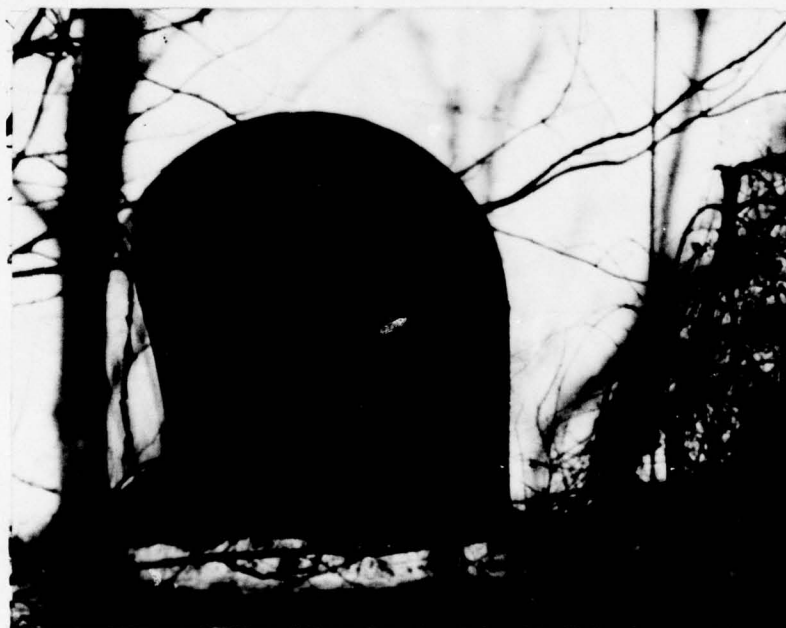
View of Spillway Outlet

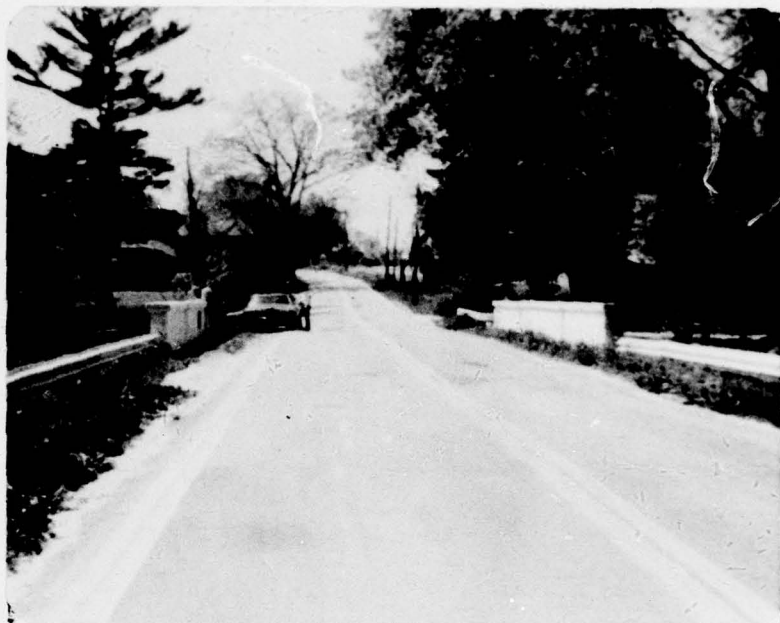
View of Crest Looking Southwest May, 1979
